PAWTUCKET RESERVOIR DAM

R.I. 00803

PHASE I INSPECTION REPORT
NATIONAL DAM INSPECTION PROGRAM

DEPARTMENT OF THE ARMY
NEW ENGLAND DIVISION, CORPS OF ENGINEERS
WALTHAM, MASS. 02154

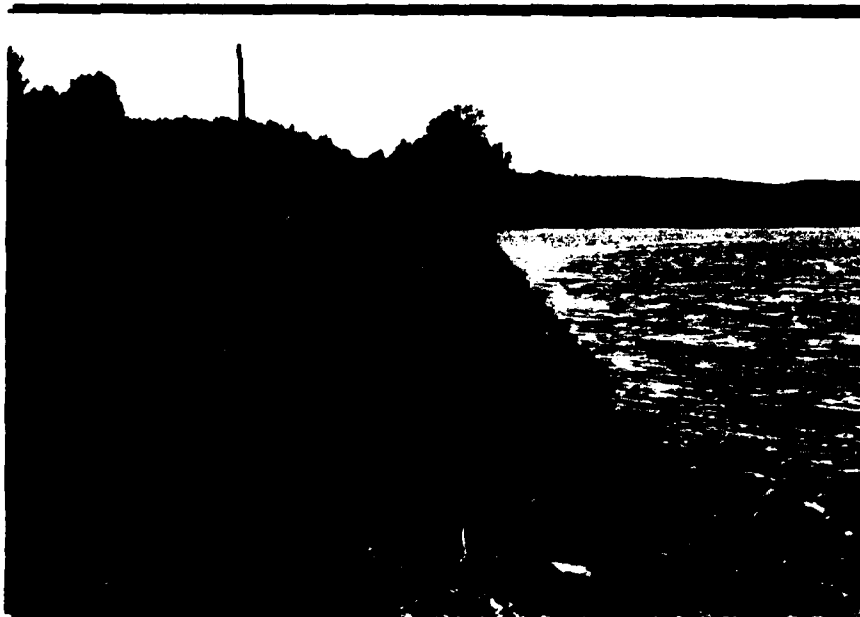
Overview of dam from left abutment
will
